Arbeitsbericht NAB 22-04

TBO Bachs-1-1: Data Report

Dossier I Drilling

August 2023

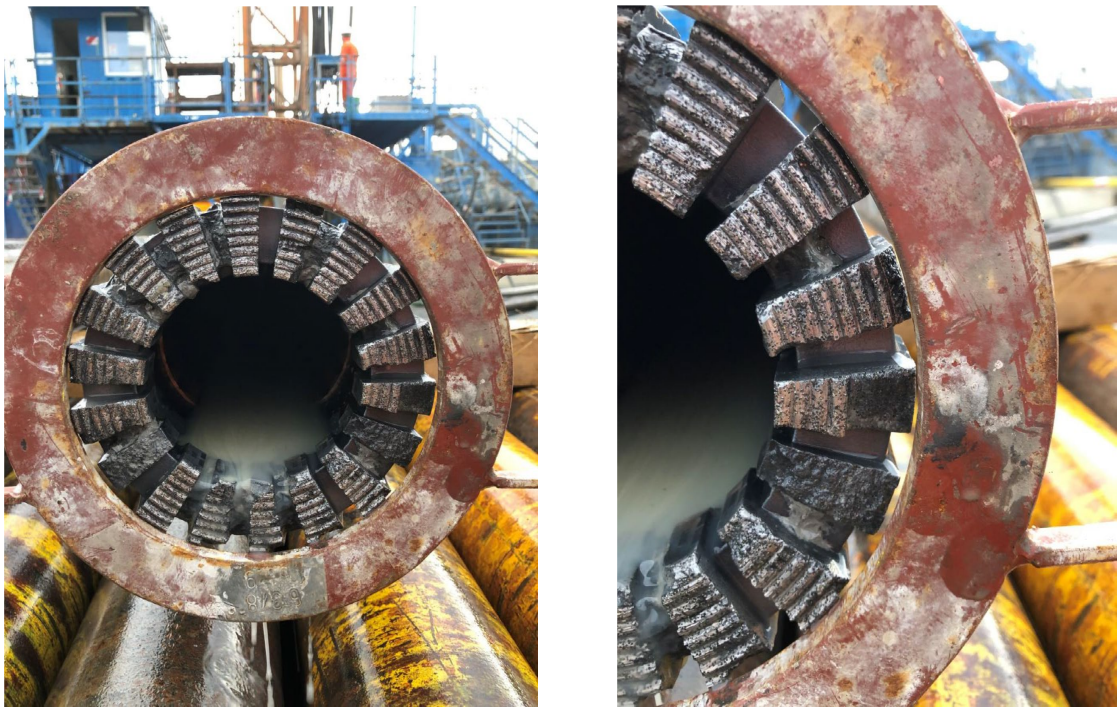
After successfully coring through the Malm limestones to a depth of 700 m MD, the coring string was POOH to perform the upcoming logging and testing programme. The core bit showed significant wear with several broken teeth (see Fig. 3-4).

Fig. 3-4: Impregnated core bit after POOH from a depth of 700 m MD

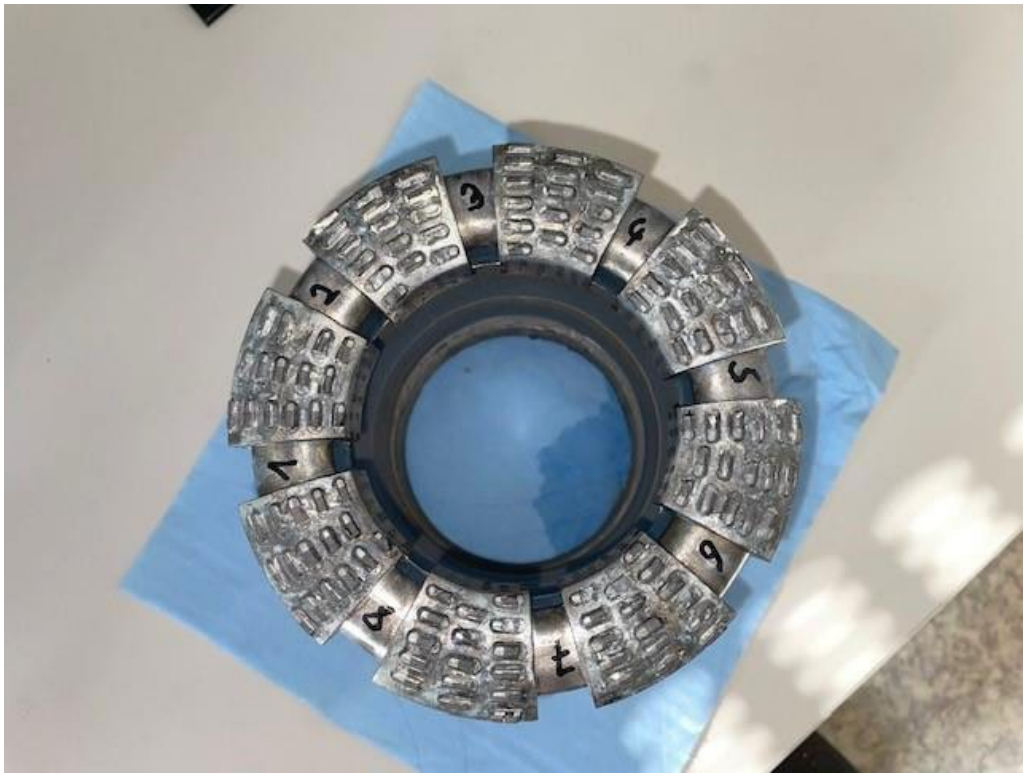
With increasing depth standpipe pressure started to increase until it was decided to POOH at 832 m MD to change the core bit. The synset core bit showed several broken cutters but normal wear after drilling 123 m (see Fig. 3-5).

Fig. 3-5: Synset core bit after POOH from a depth of 832 m MD

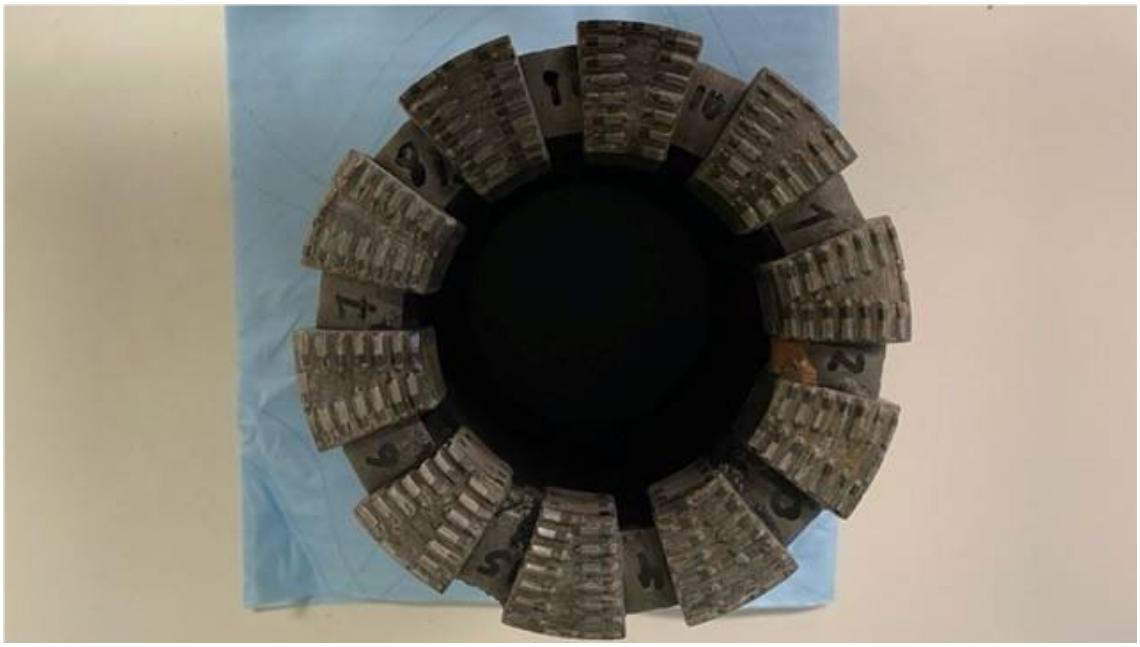
As the cores were heavily jammed due to a fault it was decided to stop at 952 m MD and end the section for the upcoming logging and testing program. The synset core bit showed normal wear after drilling 51 m (see Fig. 3-7).

Fig. 3-7: Synset core bit after POOH from a depth of 952 m MD
